LigoVision wireless Innovation Resolves Network Issues at Kansas City Data Center, USA

Convergent Technologies encountered network malfunctions at a data center's vehicle gate due to a shorted Cat6 cable and complex conduit issues. Implementing LigoVision wireless devices provided a quick, cost-effective solution, restoring reliable security connectivity.

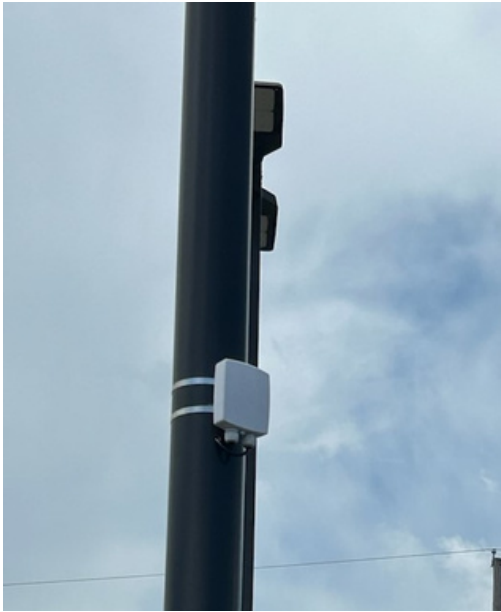
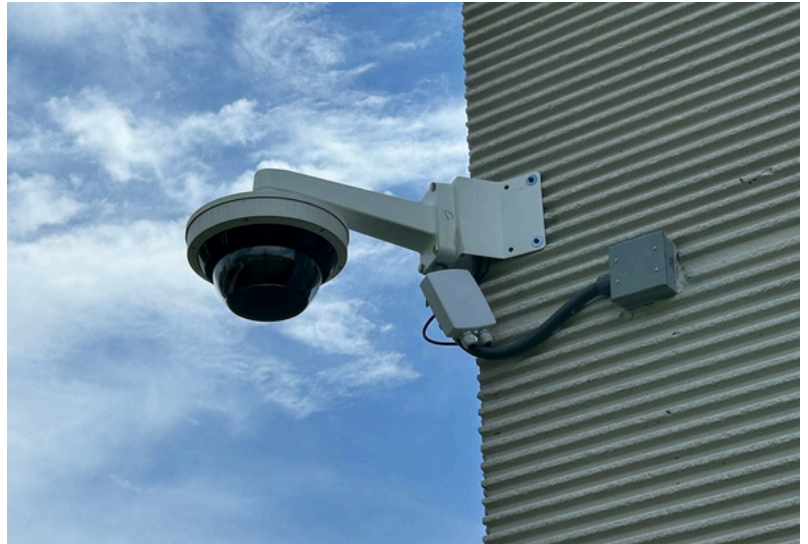
Convergent implemented LigoVision wireless data transfer devices, utilizing existing power and installing a POE network switch within a NEMA enclosure. This wireless setup established a robust connection between the gate and the building, successfully bringing all network devices online and ensuring proper security at the vehicle gate.

To address the network malfunctions caused by the shorted Cat6 cable, Convergent Technologies implemented a LigoVision wireless data transfer solution. They utilized the existing power at the vehicle gate to install a POE network switch within a NEMA enclosure. The malfunctioning network devices were rerouted to this switch. A LigoVision unit was then mounted on a camera pole to establish a wireless connection to the switch, with a corresponding receiving unit installed on the building and connected to the network. Positioned 350 feet apart with a clear line of sight, the LigoVision units provided a robust and secure wireless signal, effectively restoring the network and ensuring reliable security at the gate.
